# Profile of subgrade subsidence in Sorchen

Nimesh Chettri<sup>1</sup>, Indra Bdr.Chhetri<sup>2</sup>, Karma Yangzom<sup>3</sup>

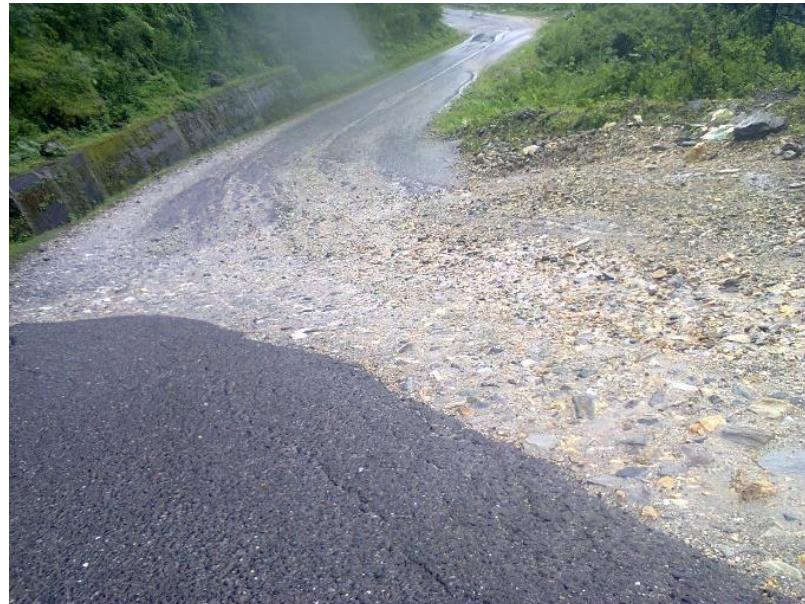
Fig 2: Road Section in Sorchen (Zone-4) showing the subsidence profile

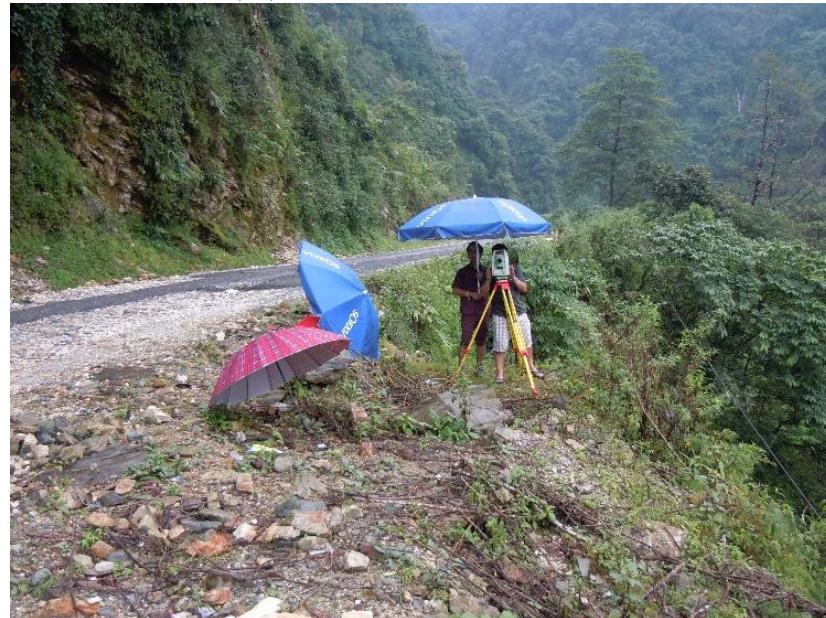
Fig 3: Subsidence depth measurement

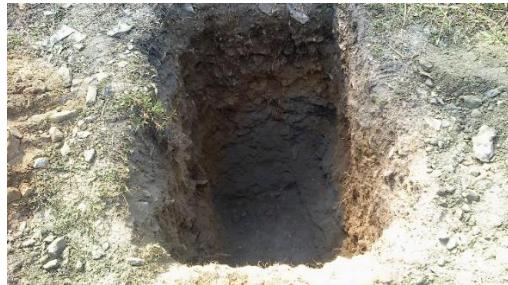
*Fig 8: Trial pit sampling of study area*
